EXECUTIVE SUMMARY

This study provides assessment of safety and economic geohazard risk, and development of conceptual risk control options, for 35 creeks within the District of North Vancouver (DNV). The creeks assessed are subject to flood, debris-flood or debris-flow processes (debris geohazards) with the potential to cause economic damages and loss, and/or pose risk to life for persons within buildings.

Debris Hazard Impact Assessment - Main Report

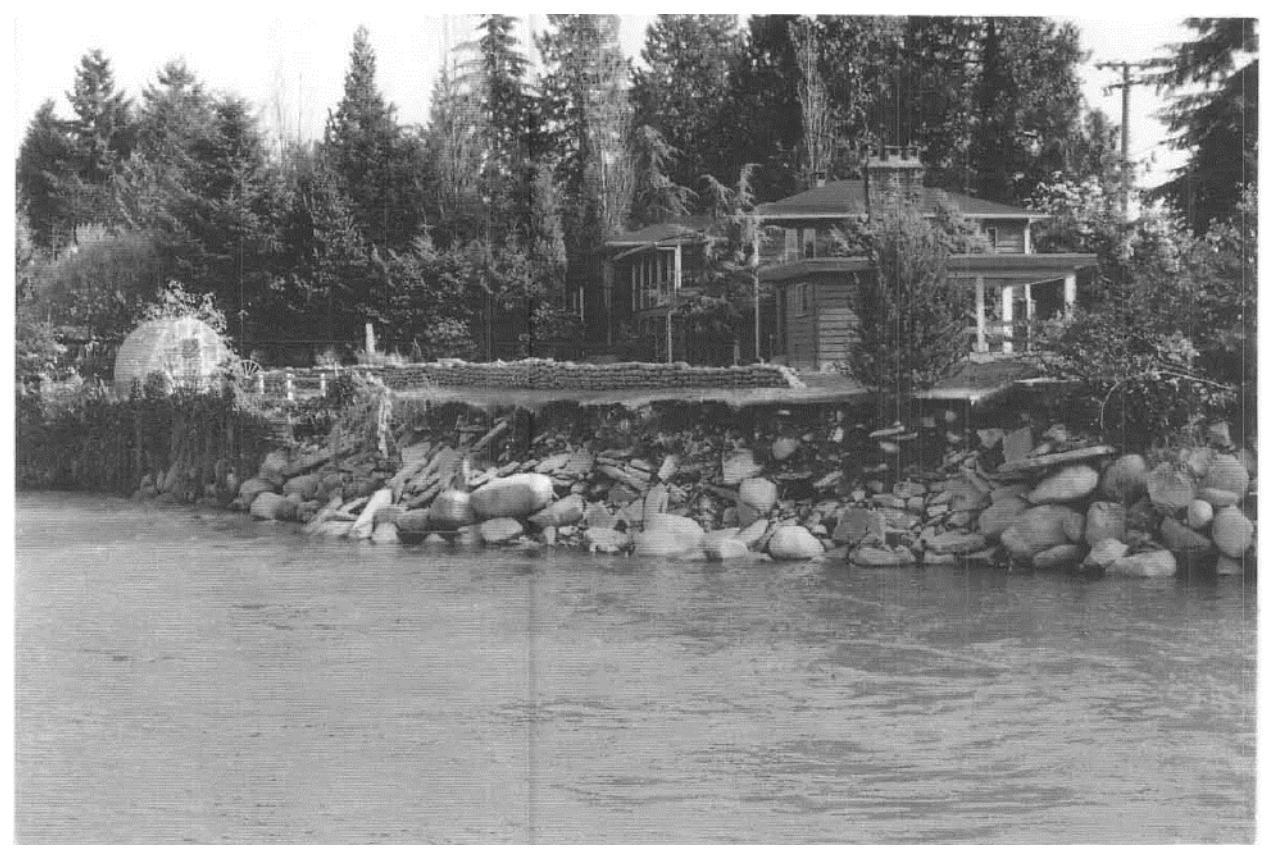
Figure A.1-1. Seymour River looking upstream at the east bank upstream of the Dollarton Highway Bridge following the October 31, 1981 storm showing severe bank erosion (Province of BC Ministry of Environment, 1995).

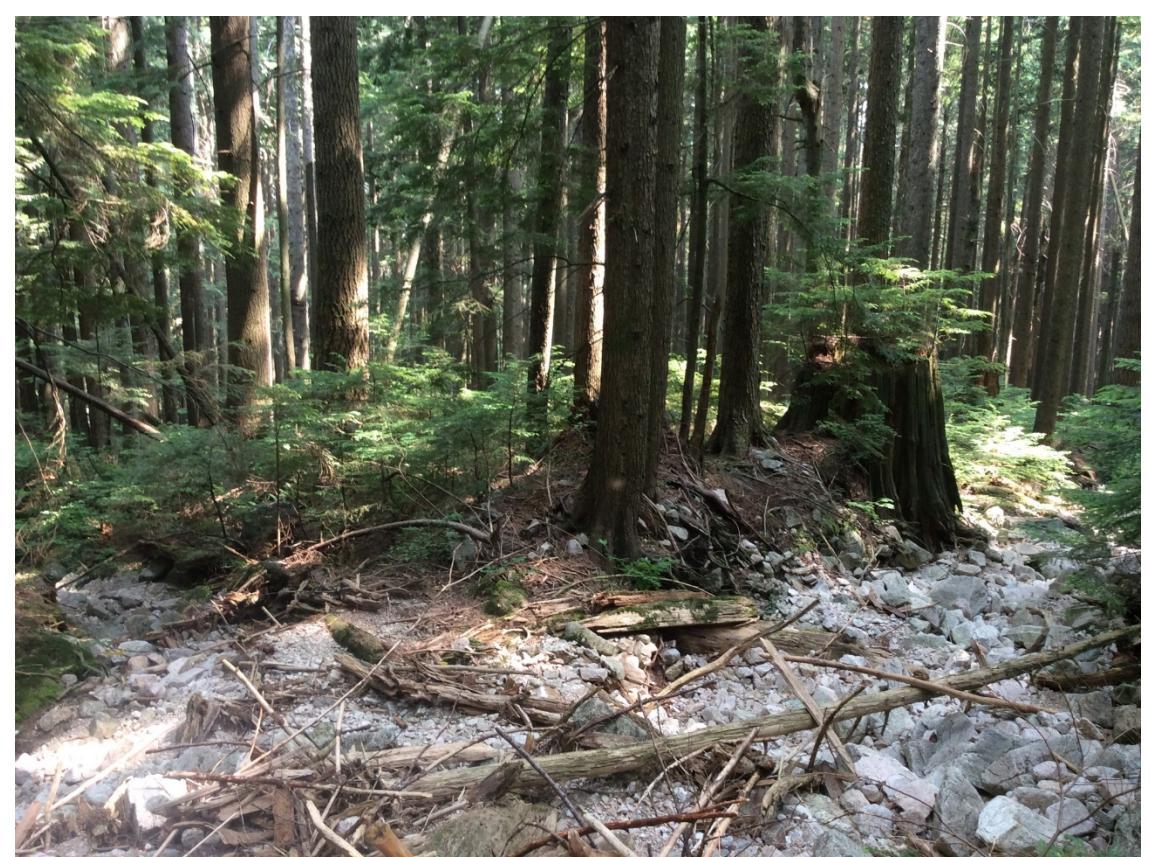
The second anomaly derives from a location about 600 m downstream of the seventh switchback and about 100 m upstream of the Old Grouse Mountain Highway. Here, the creek splits into two channels, Thames draining to the east and Kilmer draining to the west (Photograph A.1-1). The flow split is likely a legacy of past logging, as a number of old skid roads dissect the slopes in this area. The flow split allows creek flows to continue to flow south within the Kilmer Creek channel or divert to the southeast and enter the Thames Creek drainage. During the November 2014 storm, it appears that most of the flow remained in the Kilmer Creek channel, but it is possible that some flow was diverted into Thames Creek, exacerbating flood conditions in that watershed. Furthermore, future aggradation in the location of the flow split could lead to a larger portion entering the Thames Creek watershed.

Photograph A.1-1. Looking downstream at flow split between Kilmer Creek (right) and Thames Creek (left). BGC photograph of July 7, 2015.

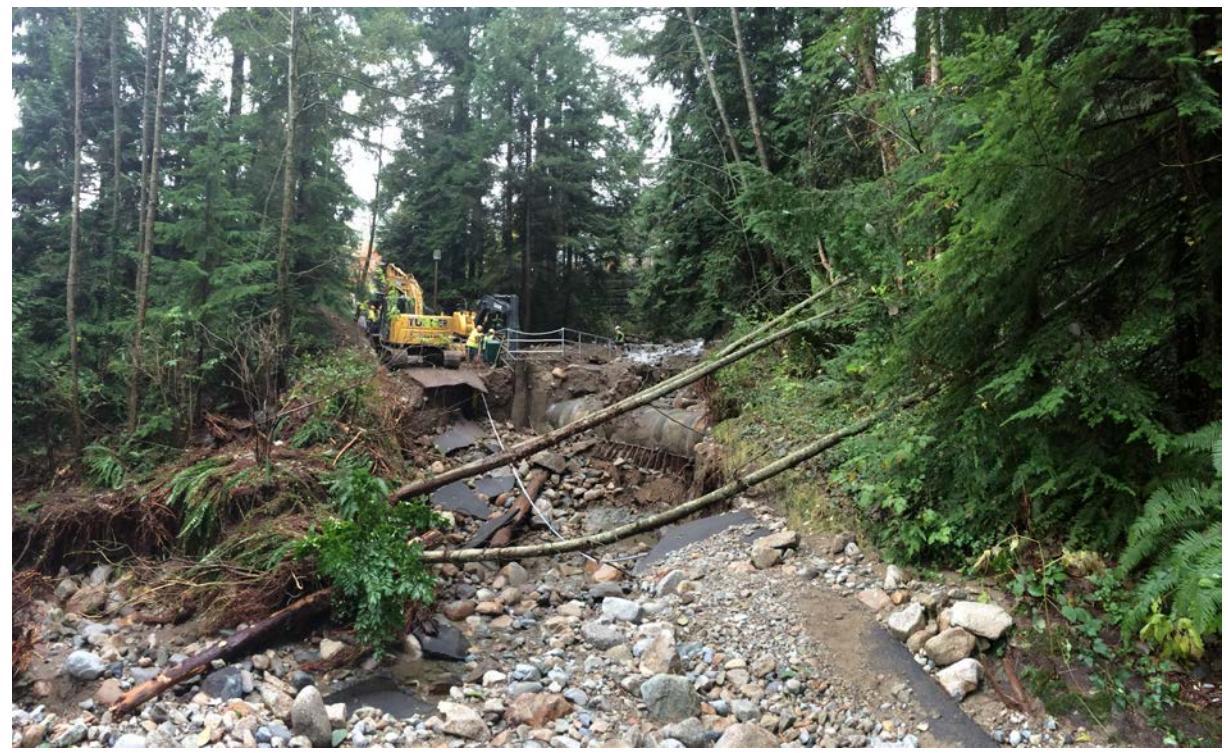
Photograph A.1-6. Upstream view toward the Kilmer Creek Diversion. BGC photograph of November 4, 2014.

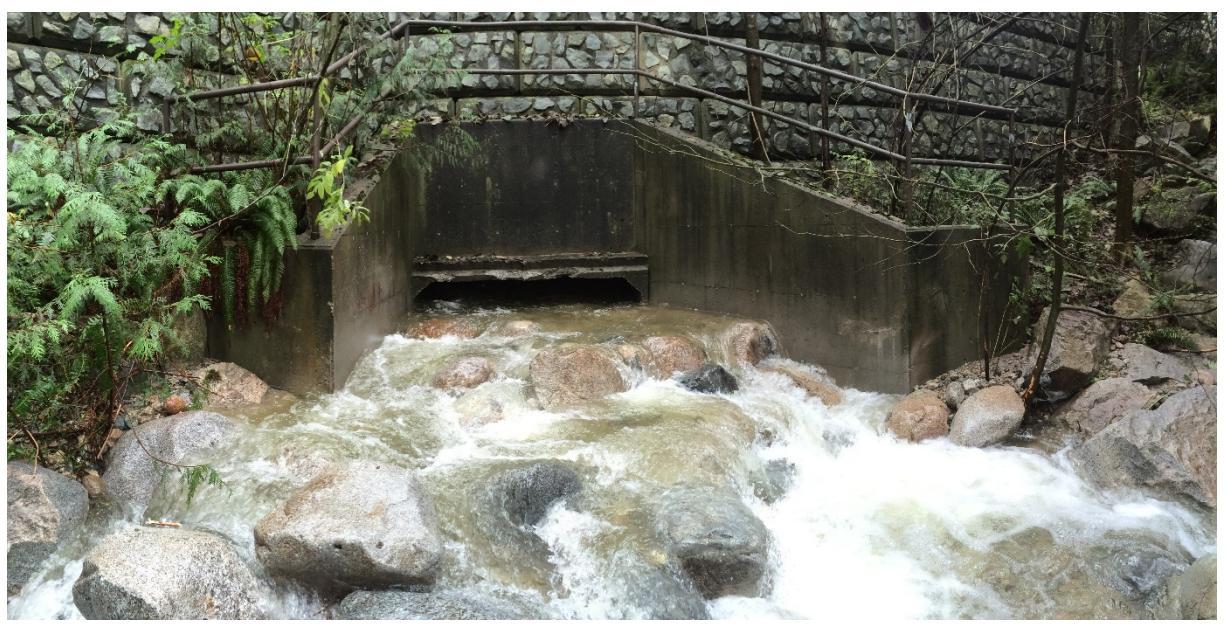
Photograph A.1-7. Upstream view of Kilmer Creek box culvert under Michener Way following the November 2014 debris flood. BGC photograph of November 4, 2014.

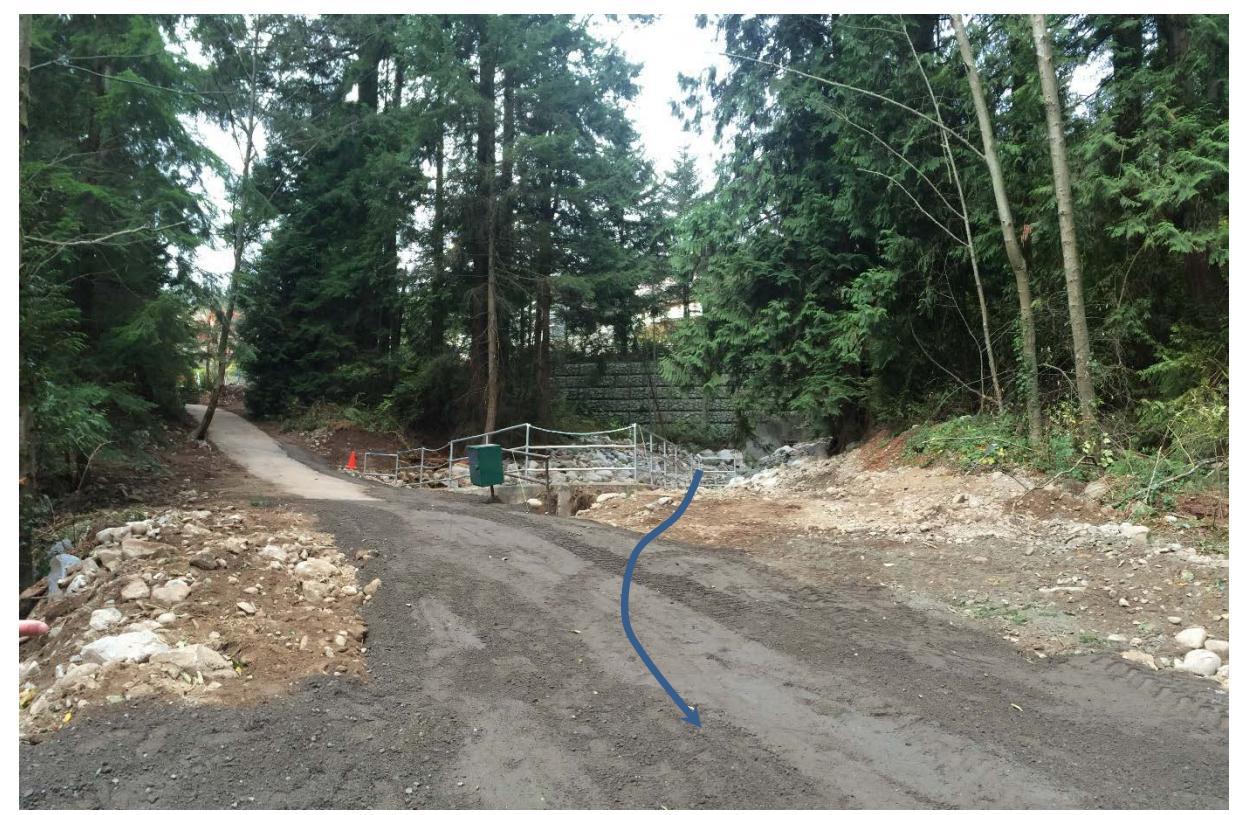
Photograph A.1-8. Upslope view of the Kilmer Creek Diversion intake from the access road. The avulsion flow path is delineated in blue. BGC photograph of November 18, 2014.

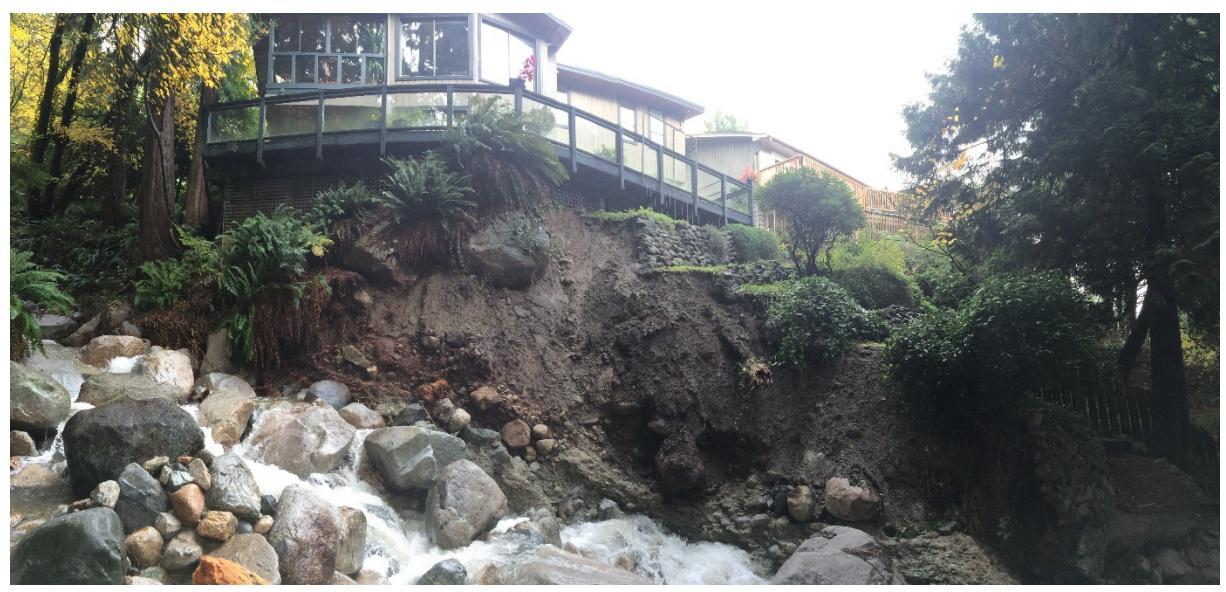
Photograph A.1-9. View looking east of eroded fillslope adjacent to 1017 Doran Road. BGC photograph of November 4, 2014.

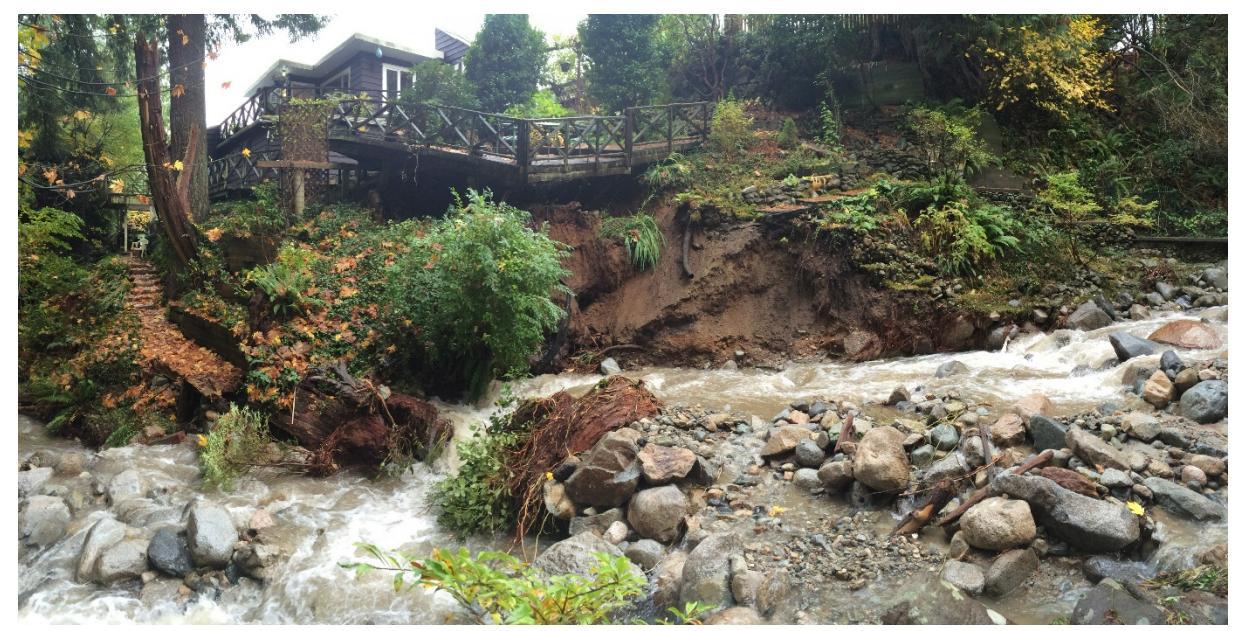
Photograph A.1-10. View looking west of eroded bank of Kilmer Creek at 1014 Wellington Drive. BGC photograph of November 4, 2014.

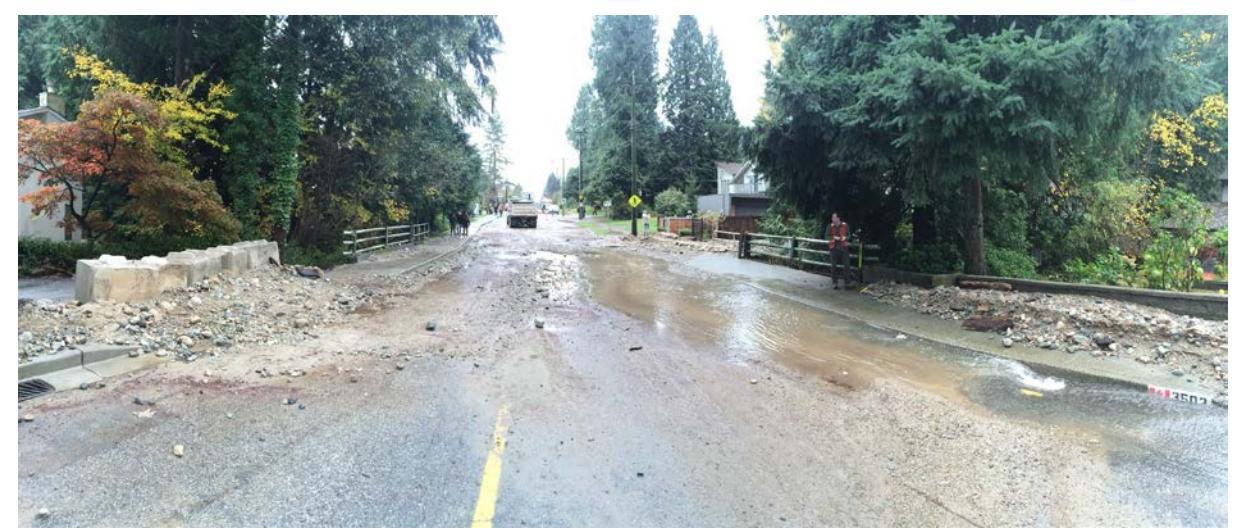
Downstream of Wellington Drive, sediment mobilized in lower reaches of Kilmer Creek blocked the 1800 mm diameter culvert at Fromme Road. These overflows, combined with the overland flows from further upstream, continued down Fromme Road, eventually discharging into Hastings Creek (Photograph A.1-11). Properties on either side of Fromme Road were impacted by these overland flows (Drawing A-1). Approximately 130 m³ of sediment was removed by DNV personnel from streets and properties following the debris flood (Mike Blackmon, pers. comm.).

Photograph A.1-11. Downstream view of Fromme Road at Hastings Creek. BGC photograph of November 4, 2014.

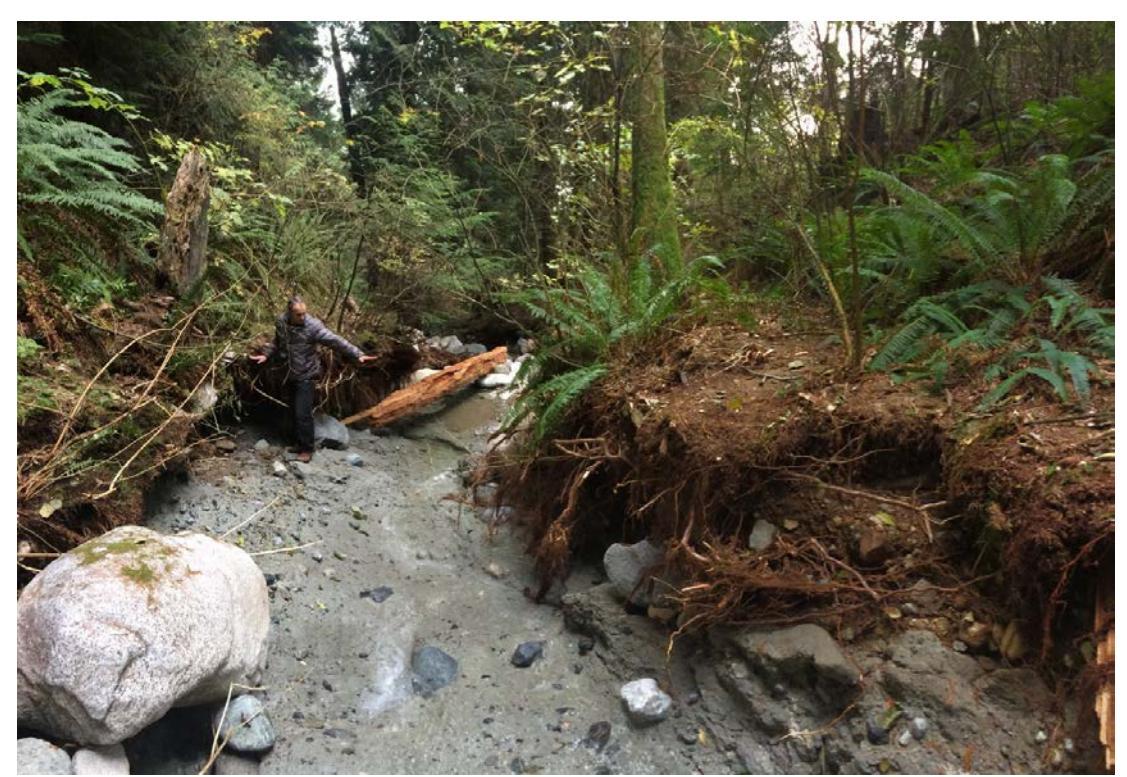
The entire channel from Dempsey Road up to the Old Grouse Mountain Highway showed evidence of channel disturbance across the full channel width. Locally, the channel had scoured down to bedrock or the dense basal till (Photograph A.1-12, Photograph A.1-13). Channel aggradation was associated with local changes in channel gradient or large woody debris jams (Photograph A.1-14, Photograph A.1-15, Photograph A.1-16).

Photograph A.1-12. Upstream view of Kilmer Creek scoured down to the underlying dense basal till. The hands of the person in mid picture indicate the approximate high water mark. BGC photograph of November 4, 2014.

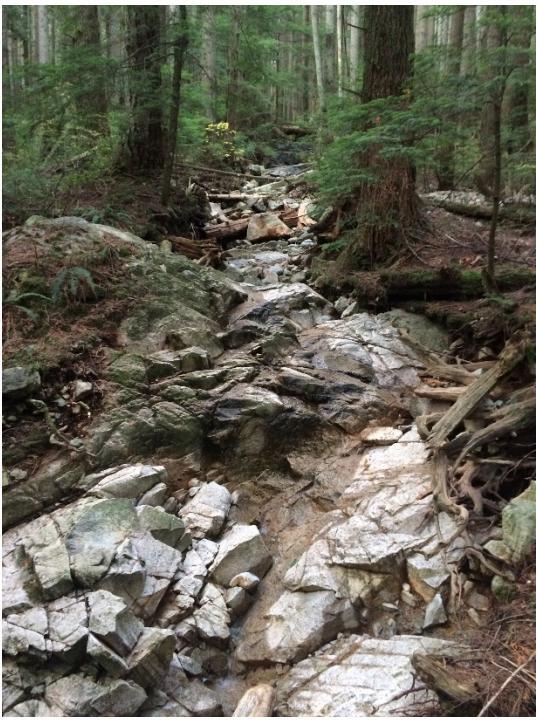
Photograph A.1-13. Upstream view of Kilmer Creek scoured to bedrock. BGC photograph of November 18, 2014.

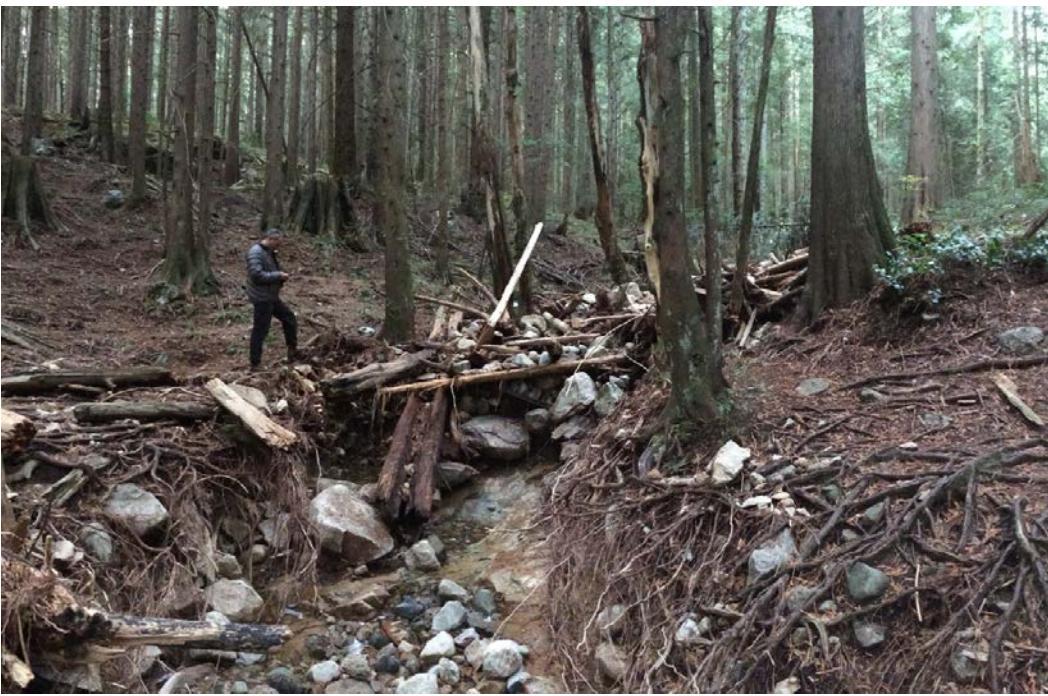
Photograph A.1-14. Upstream view of sediment wedge developed behind a woody debris jam and large locked-in boulder. BGC photograph of November 18, 2014.

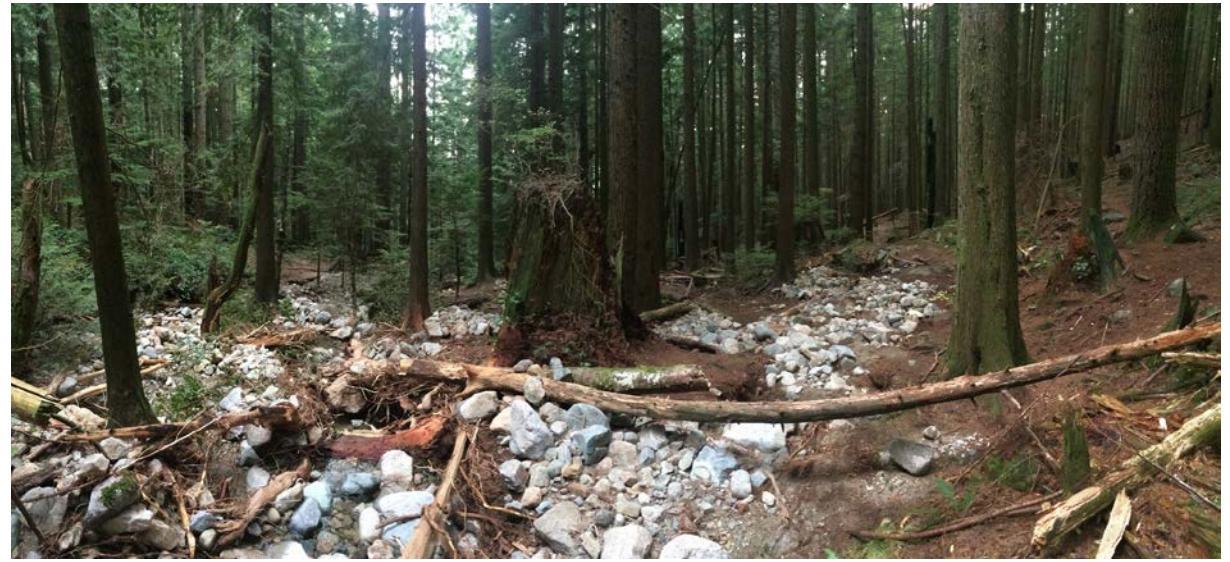
Photograph A.1-15. Downstream view of sediment deposition and channel avulsion in a lower gradient channel section of Kilmer Creek. BGC photograph of November 18, 2014.

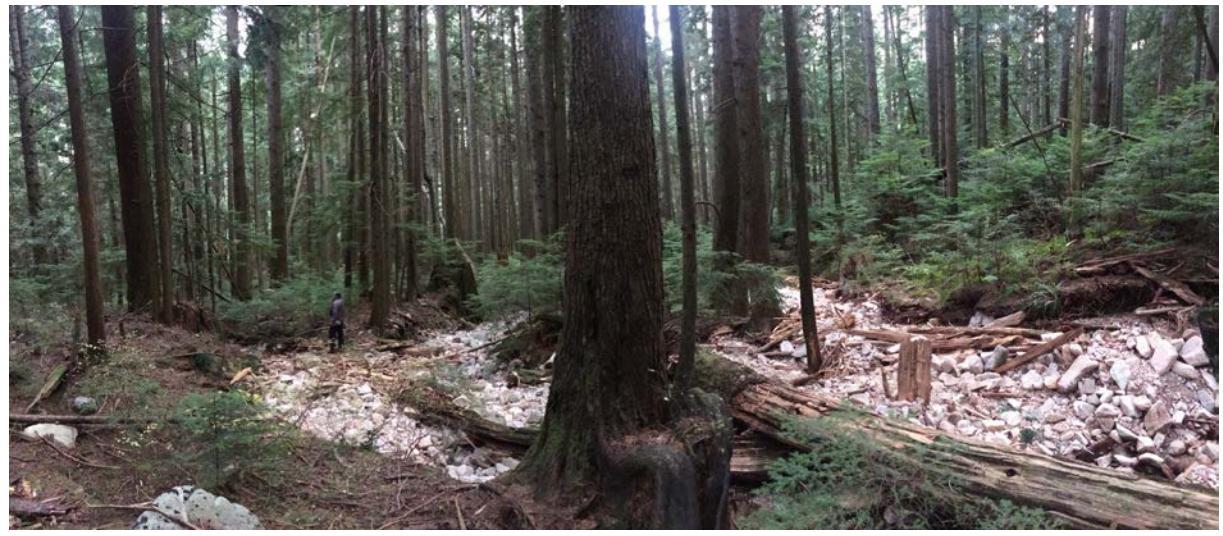
Photograph A.1-16. Downstream view of sediment deposition in a lower gradient channel section of Kilmer Creek. BGC photograph of November 18, 2014.

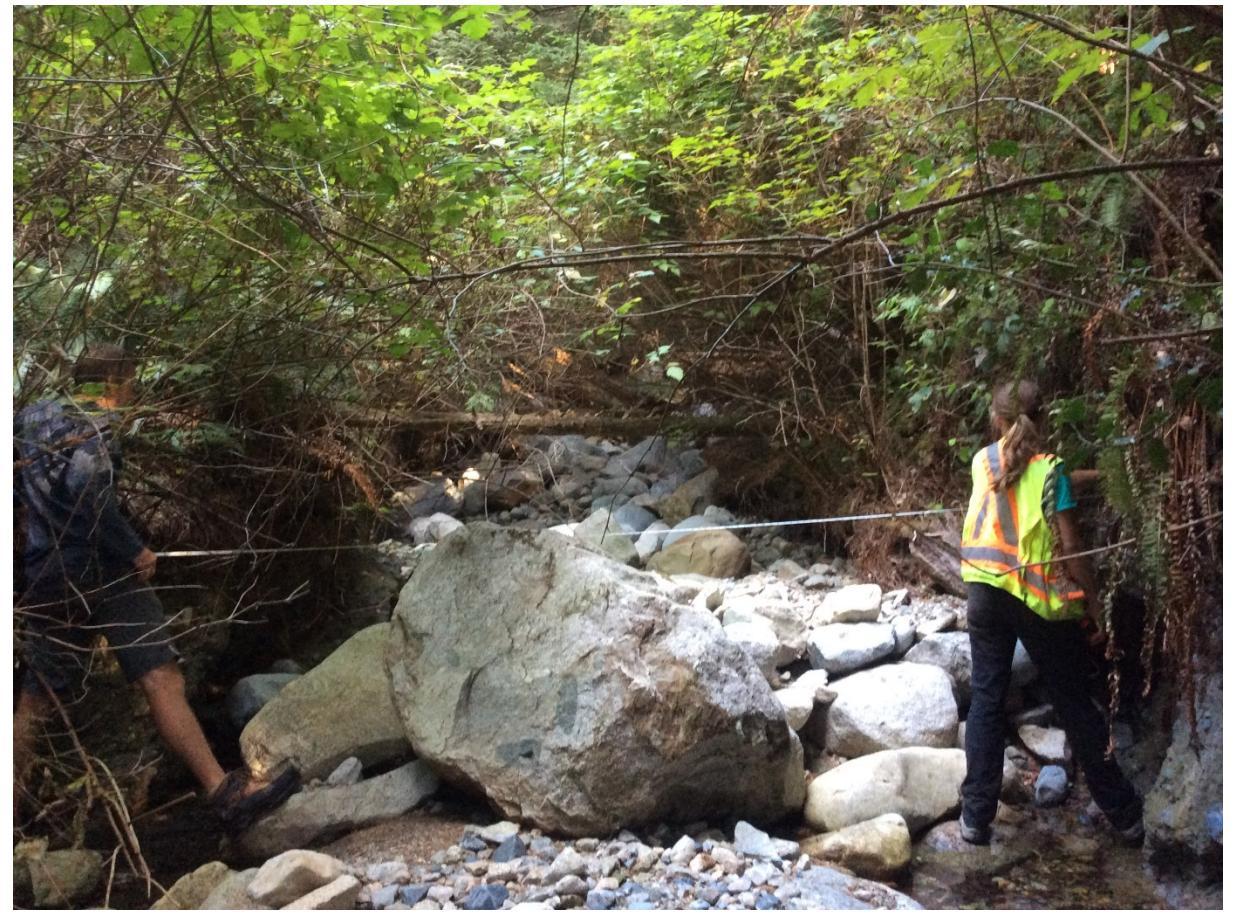
The peak flow of the 2014 November debris flood on Kilmer Creek were back-calculated based on high water marks observed along the channel, about 100 m upstream of Dempsey Road. Here, a 25 m section of creek displayed well-developed high water marks (Photograph A.1-17).

Photograph A.1-17. Upstream view of a high water mark measurement on Kilmer Creek. BGC photograph of August 26, 2015.

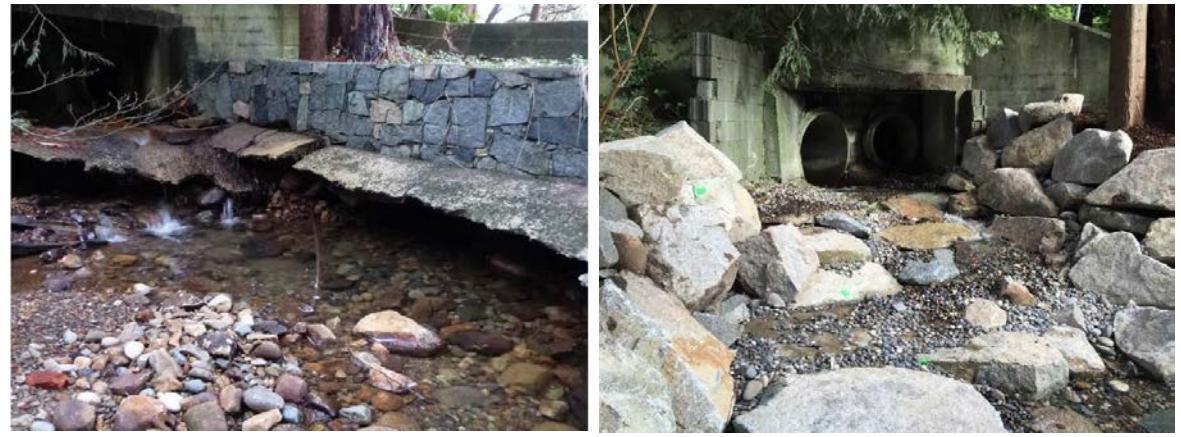
A 1200 mm culvert conveys Coleman Creek underneath Coleman Street (STMCUL0400) and discharges into the western corner of 1343 Coleman Street. The alignment of the culvert directs flows toward the retaining wall and on-going erosion has undermined the retaining structure and the concrete slab at the outlet (BGC, 2015b). Following the November 2014 flood, this erosion issue became more acute and repairs were conducted by the DNV in February 2015 (Dillon, 2015b).

Figure A.1-5. Before and after views of Coleman Creek at 1343 Coleman Street (from Dillon, 2015b).

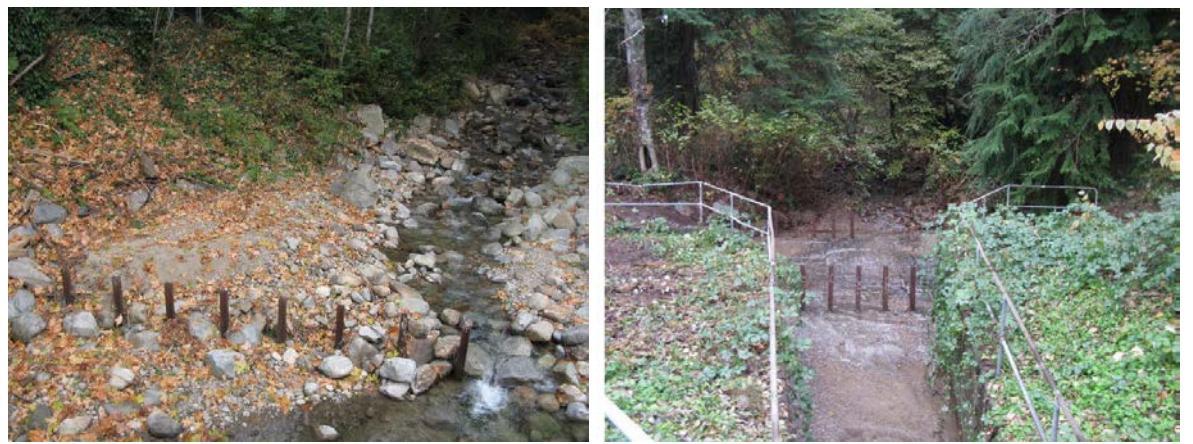
Further downstream on Mission Creek, sediment accumulated behind debris barriers constructed upstream of West Windsor Road (Dillon, 2014e) and Evergreen Place (Dillon, 2014f) (Figure A.1-6). These sediments were removed from the channel following the November 2014 flood event.

Figure A.1-6. Upstream view of Mission Creek grizzly barriers at West Windsor Road (left) and Evergreen Place (right) (from Dillon, 2014d and 2014e). The image on the left was taken prior to debris removal, while the image on the right post-dates debris removal.

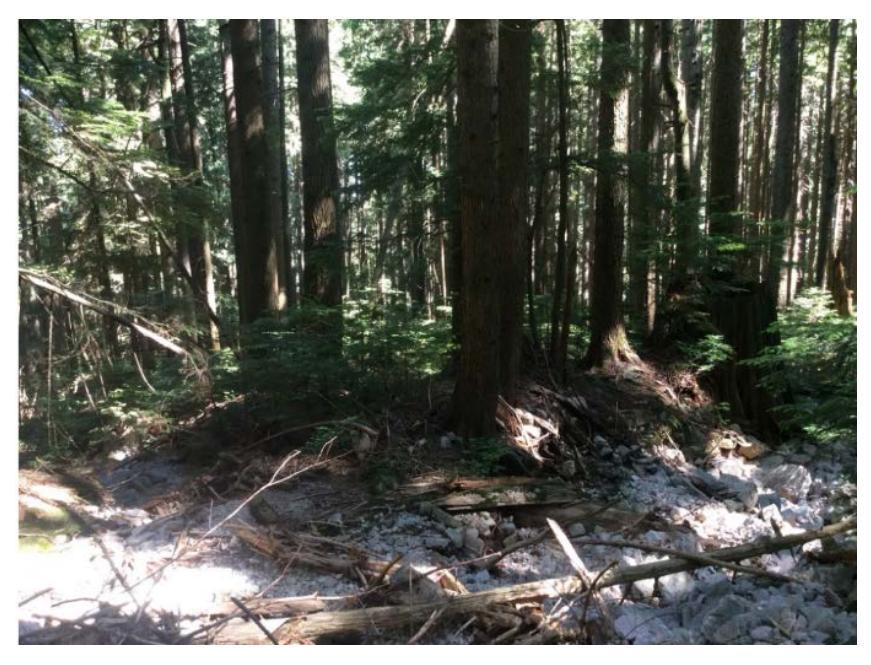
Figure O.8-5. Flow is split between Thames (left) and Kilmer (right) Creek. Photograph of July 3, 2015 looking downstream.
