EXECUTIVE SUMMARY

This study provides assessment of safety and economic geohazard risk, and development of conceptual risk control options, for 35 creeks within the District of North Vancouver (DNV). The creeks assessed are subject to flood, debris-flood or debris-flow processes (debris geohazards) with the potential to cause economic damages and loss, and/or pose risk to life for persons within buildings.

Debris Hazard Impact Assessment - Main Report

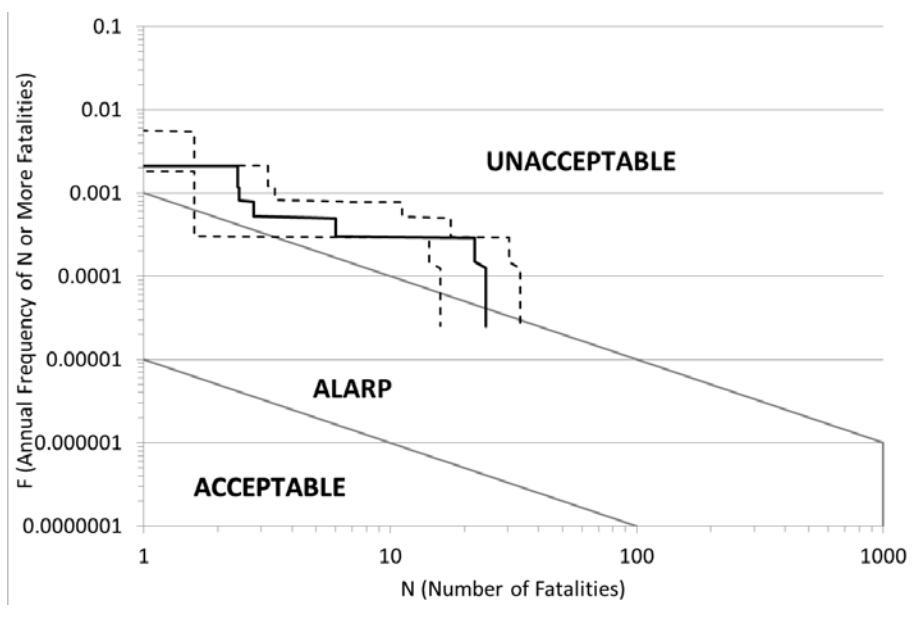
Figure 6-2 displays estimated group risk for Percy Creek on an F-N curve, which is the only urban creek where the best-estimate of group risk falls in the unacceptable range. The lower, upper and best-estimates shown on the graph reflect the range used to estimate vulnerability.

Figure 6-2. F-N Curve for Percy Creek.

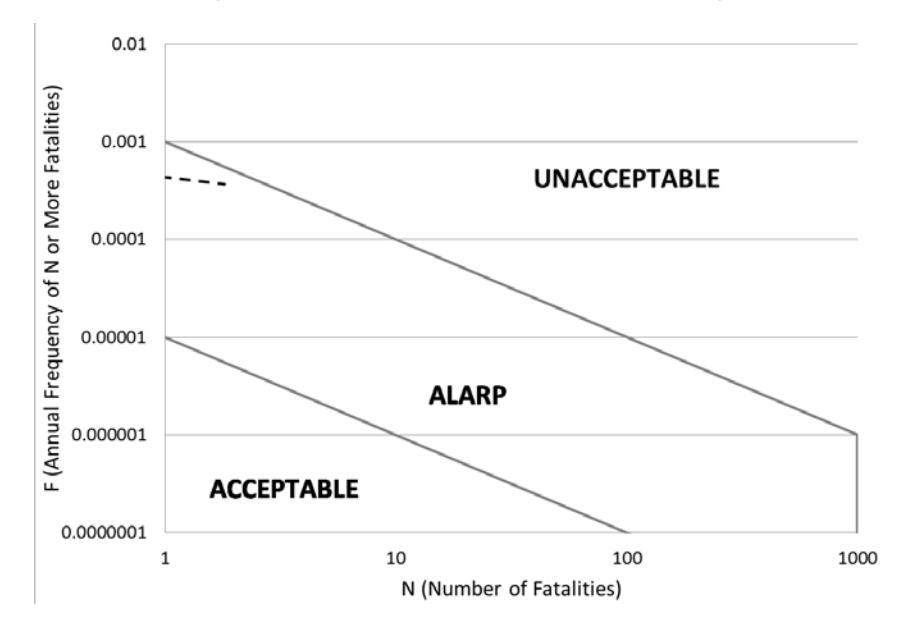
Figure 6-3 displays estimated group risk for Mosquito Creek. Only the upper range estimate is shown because no fatalities¹⁷ were estimated for the lower and best-estimate. It falls within the ALARP zone. Note that this result is based on hazard scenarios that include the effect of the debris flood net at the development interface to reduce risk on Mosquito Creek.

Figure 6-3. F-N Curve for Mosquito Creek, with the debris flow net installed.

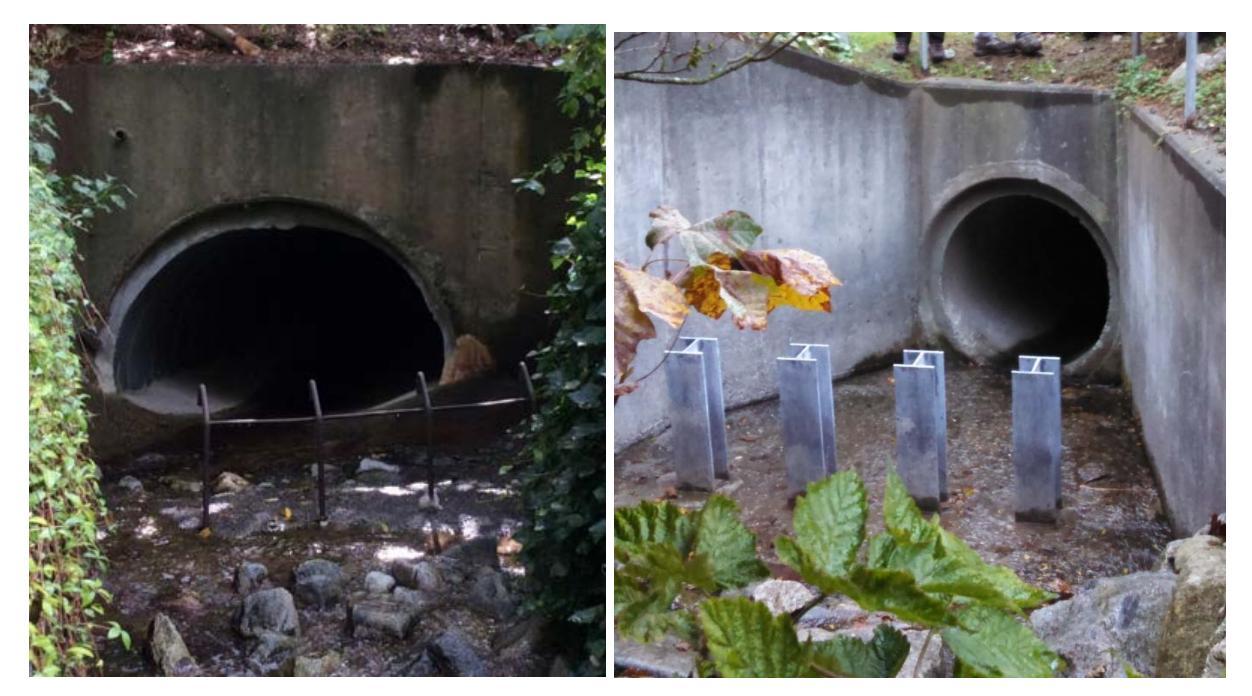
Figure 7-2. Standard debris barriers specified by DNV Development Servicing Bylaw 7388. Small watercourse barrier (left). Large watercourse barrier (right).

Culvert inlet protection that is currently in place in DNV varies widely in terms of both design and effectiveness¹⁹, and frequently is not consistent with the DNV design standard. General observations of the design and effectiveness of existing culvert inlet protection, includes:

- Barriers are typically effective at stopping downstream movement of boulders.
- Barriers are typically not effective at stopping downstream movement of sand, gravel, and cobble-sized sediment.
- Woody debris (e.g., small sticks, leaves) is typically retained on the upstream side of barriers, and BGC understands that this debris is removed frequently by DNV maintenance staff.
- Barrier height is often less than the expected flow depth during storm events, and therefore woody debris typically floats over the top of the barrier during storm events.
- The position of barriers along the channel is typically not optimized to maximize potential sediment storage volume.
- The horizontal rebar member on the downstream side of the small watercourse barrier (Figure 7-2) is sometimes detached from several of the vertical rebar members due to failure of the weld.

DNV should enforce a design standard for future culvert inlet protection installations. Bylaw 7388 drawings (SSD-D.11, 12) appear to be suitable design standards, although the following modifications could improve inlet protection effectiveness (Figure 7-3):

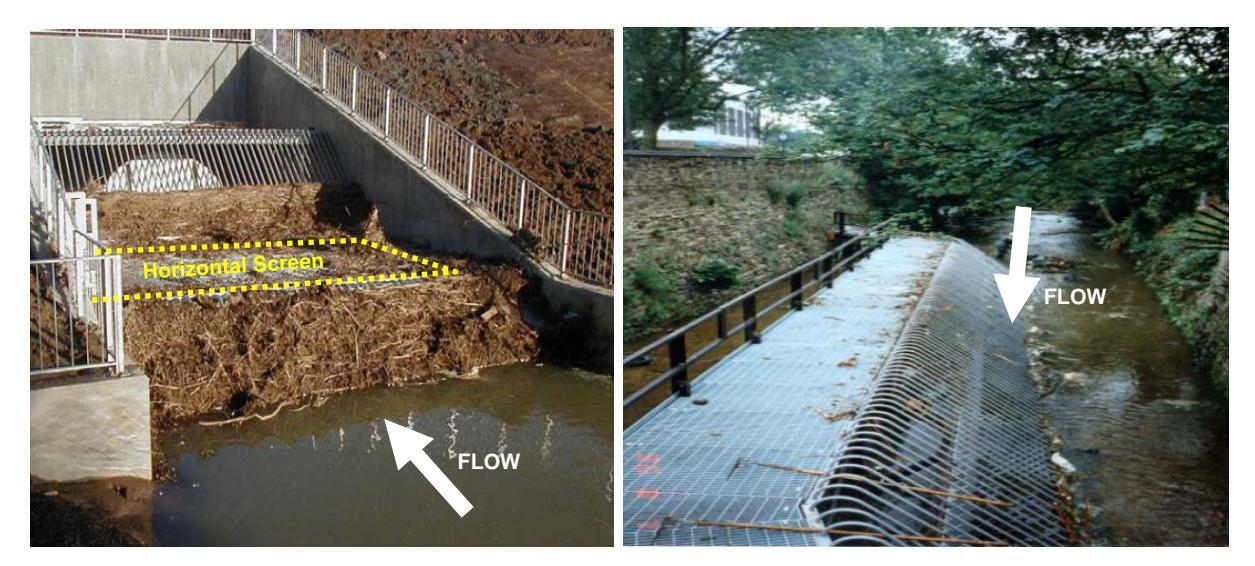
Figure 7-3. Trash rack layout options. Horizontal screen segments (left). Oriented diagonally across channel (right). Images from EA (2009).

- In general, the screen area should be approximately 10 times the culvert area (Bradley et al. 2005). Screen areas ranging from 3 times to 30 times the culvert area may be appropriate based on site-specific characteristics (EA 2009). A larger screen area reduces the potential for screen blockage and flooding. Increased screen area can be achieved by modifying the screen alignment and layout, for example by orienting the screen diagonally across the channel or by including horizontal screen segments (Figure 7-3).

- Plan for regular cleaning of the trash rack, disposal of debris, and emergency response in the event that the screen becomes blocked during a flood event. Maintenance personnel should have safe access to the screen during flood events.

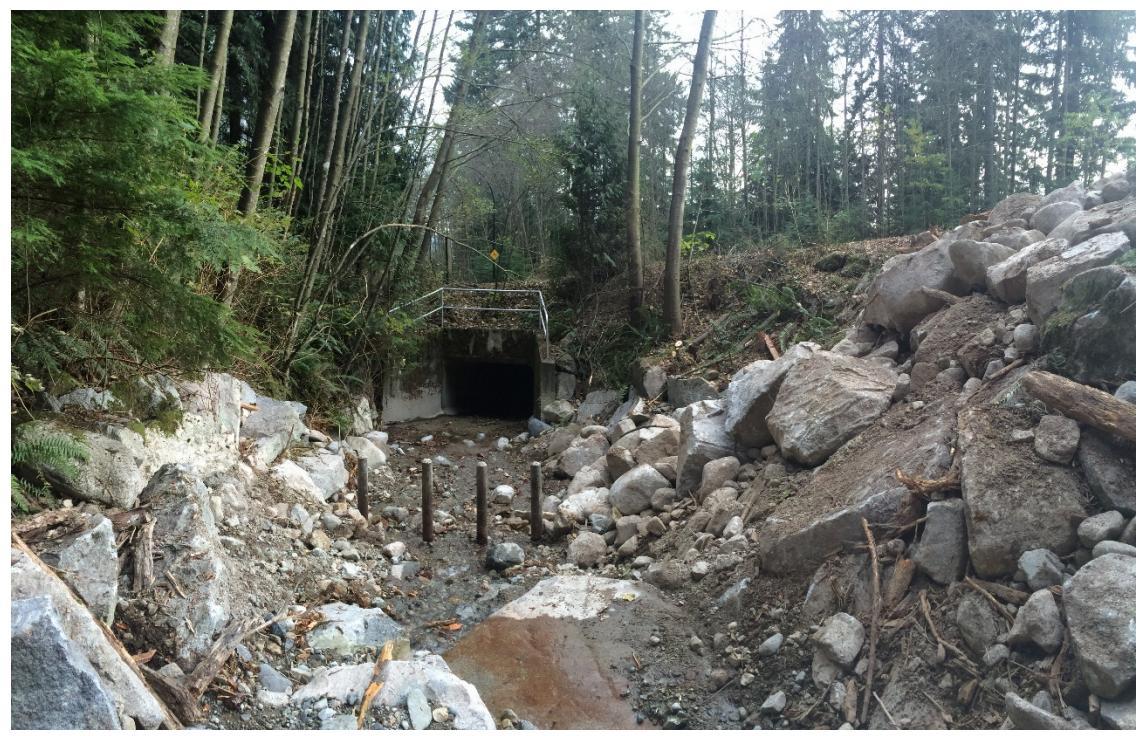
Below the Old Grouse Mountain Highway, Kilmer Creek flows to the south for about 1.4 km at an average gradient of 22% before reaching the residential development boundary at Dempsey Road. Here the creek flows through an approximate 1.4 m x 2.4 m concrete box culvert (STMCUL00507). A debris barrier, consisting of four 0.8 m high steel posts, is located above the culvert inlet and is intended to trap large woody debris and prevent blockage of the culvert (Photograph A.1-2). A tributary discharges into Kilmer Creek downstream of Dempsey Road from the east. The creek flows through a similarly-sized box culvert 75 m downstream at Michener Way (STMCUL00045) (Photograph A.1-3). Immediately below this second culvert, the creek discharges into a small basin constructed as part of the Kilmer Creek Diversion.

Photograph A.1-2. Downstream view of Kilmer Creek at Dempsey Road (STMCUL00507). BGC photograph of November 18, 2014.

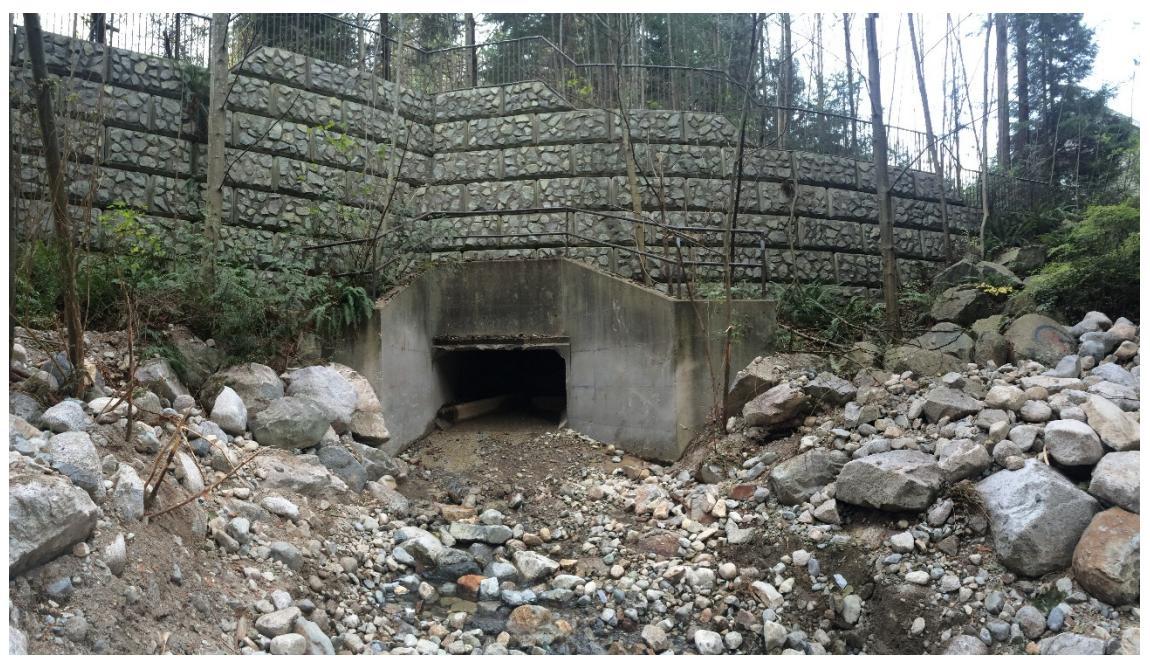
Photograph A.1-3. Upstream view of Kilmer Creek box culvert at Michener Way (STMCUL00045). BGC photograph of November 18, 2014.

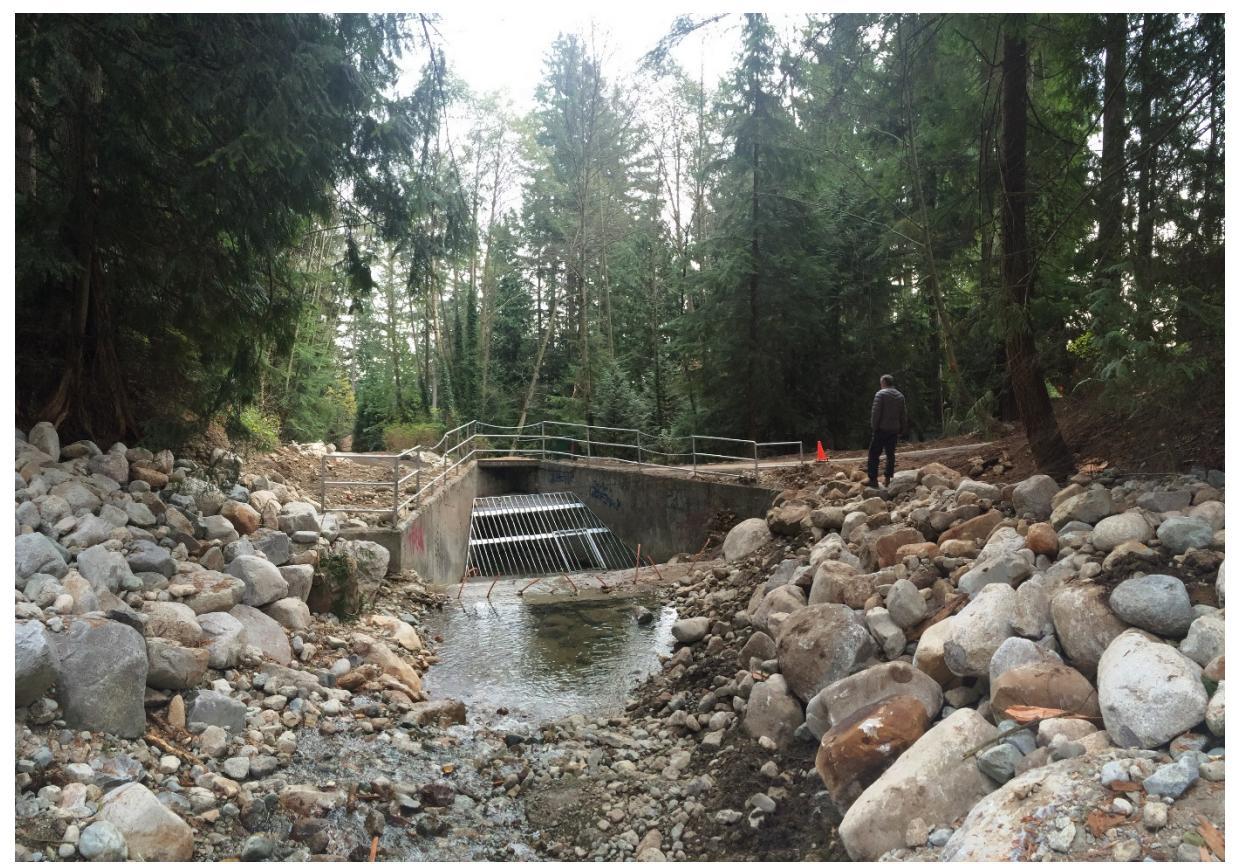
Concrete wing walls convey flow toward the diversion intake, while a trash rack envelops the entire structure. The trash rack prevents members of the public to enter the culverts, but also prevents woody debris from entering the culverts and blocking them (Photograph A.1-4). Similar trash racks have been constructed at the Thames Creek (STMMN09158) and Coleman Creek (STMMN09149) intakes. Both of those were reportedly blocked with woody debris during the Halloween 1981 flood, which resulted in Kilmer Road being washed out at Thames Creek (KWL, 1982).

Photograph A.1-4. Downstream view of Kilmer Creek looking at the intake structure and trash rack (STMMN04251). BGC photograph of November 18, 2014.

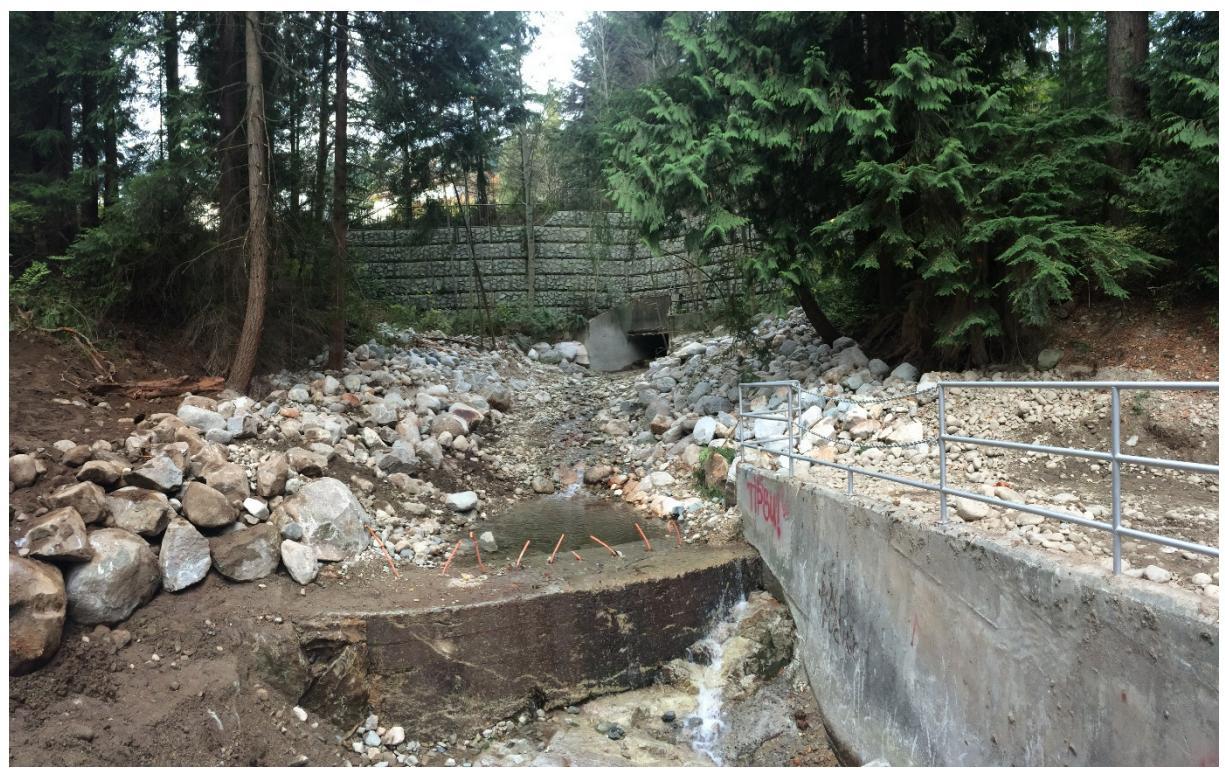
Photograph A.1-5. Upstream view of Kilmer Creek from the top of the intake structure (STMMN04251). BGC photograph of November 18, 2014.

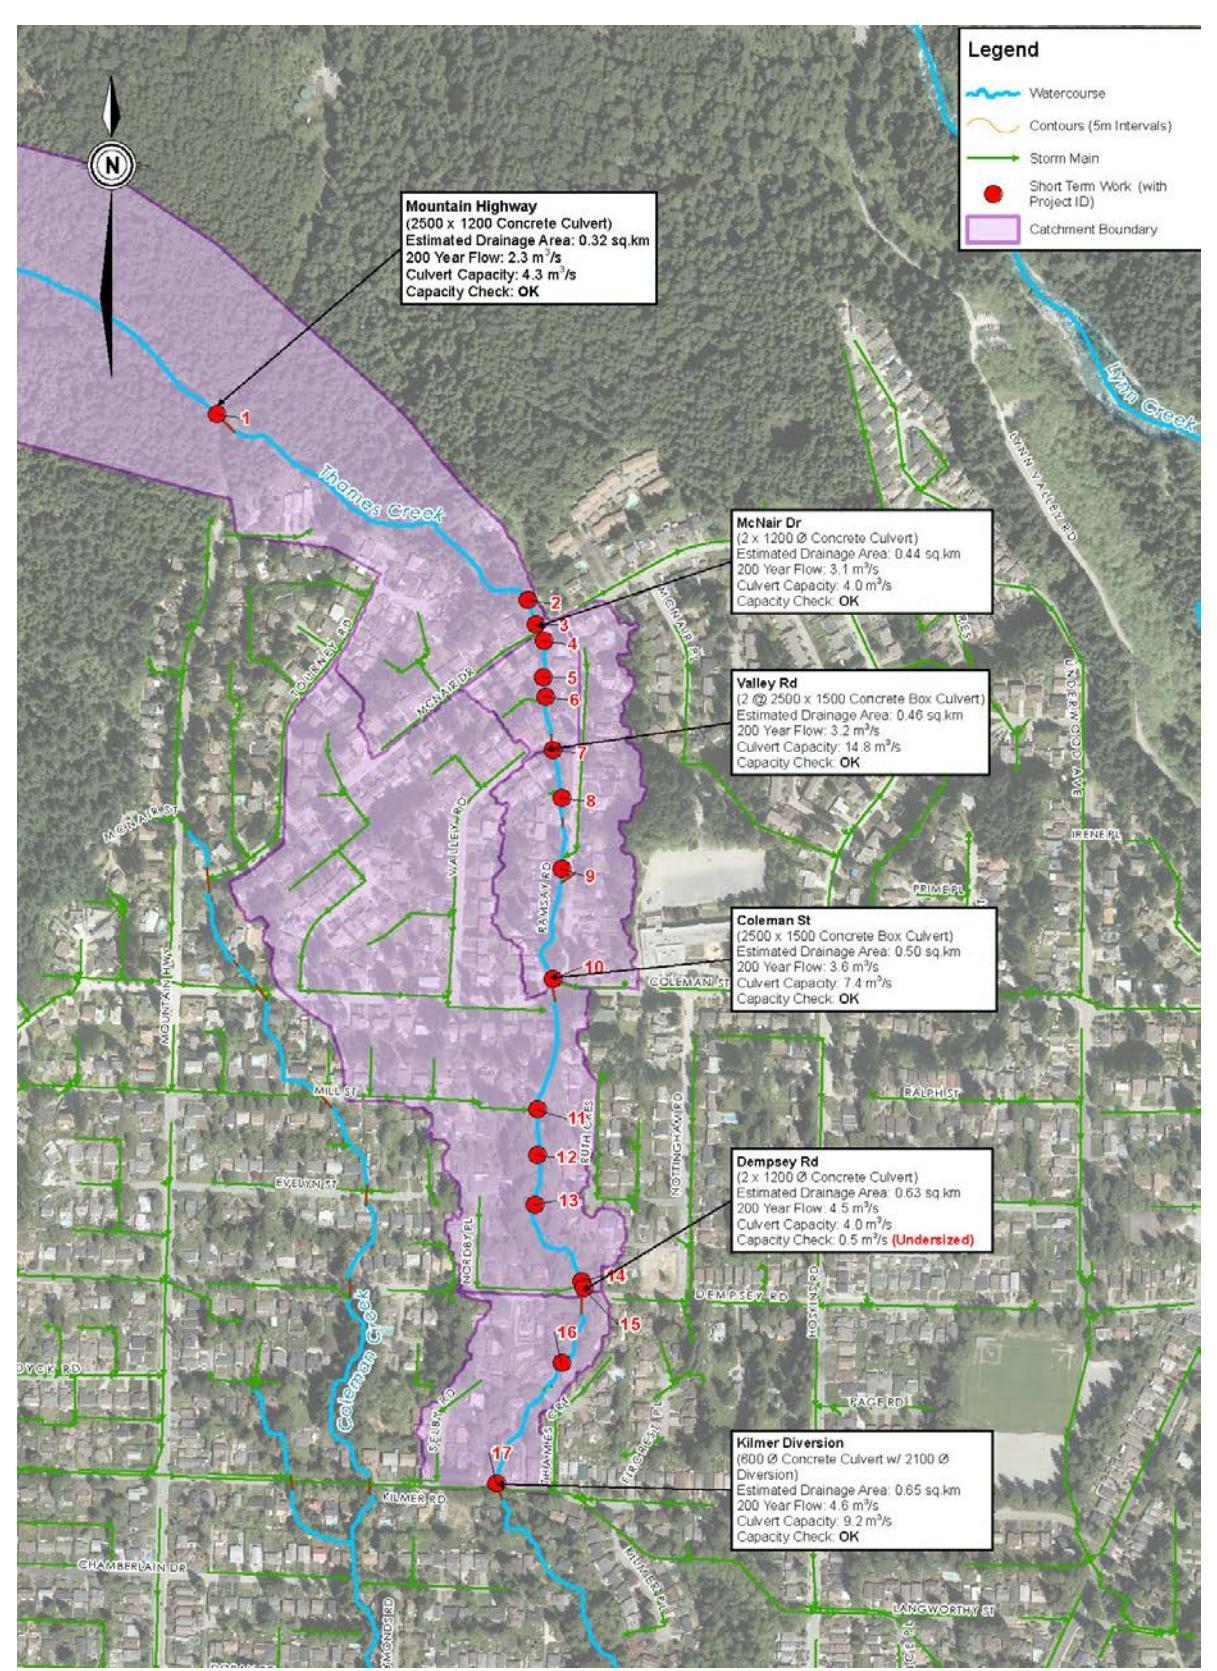
Figure A.1-4. Thames Creek potential short-term works (after KWL, 2015a).

- Consider constructing a debris interceptor upstream of the two culverts at McNair Drive (ID #2)
- Remove deposited material and overgrown vegetation at numerous locations (ID #s 3, 7, 10, 15 and 17)
- Repair riprap for a pedestrian bridge (ID #11)
- Remove a failed pedestrian bridge, reconstruct the right bank and repair/install bank protection between McNair Drive and Valley Road (ID #s 5 and 6)
- Consult an arborist regrading a tree at the crest of an eroded bank (ID #12)
- Consider installing 'grizzly' barriers (debris barriers) upstream of the two culverts at Dempsey Road (ID #14).

DNV has informed BGC that these measures are being evaluated and balanced with the findings of the present study. In addition, the DNV has retained ISL Engineering and Land Services (ISL) to provide design drawings for debris barriers along Thames Creek at Mountain Highway (ID #1), McNair Drive (ID #3), and Kilmer Road (ID #17) (ISL, 2015). The barriers consist of 200 mm diameter sonotubes (steel tubes), which are embedded in concrete. The lengths and spacings specified for the tubes are unique to each crossing, as summarized below.

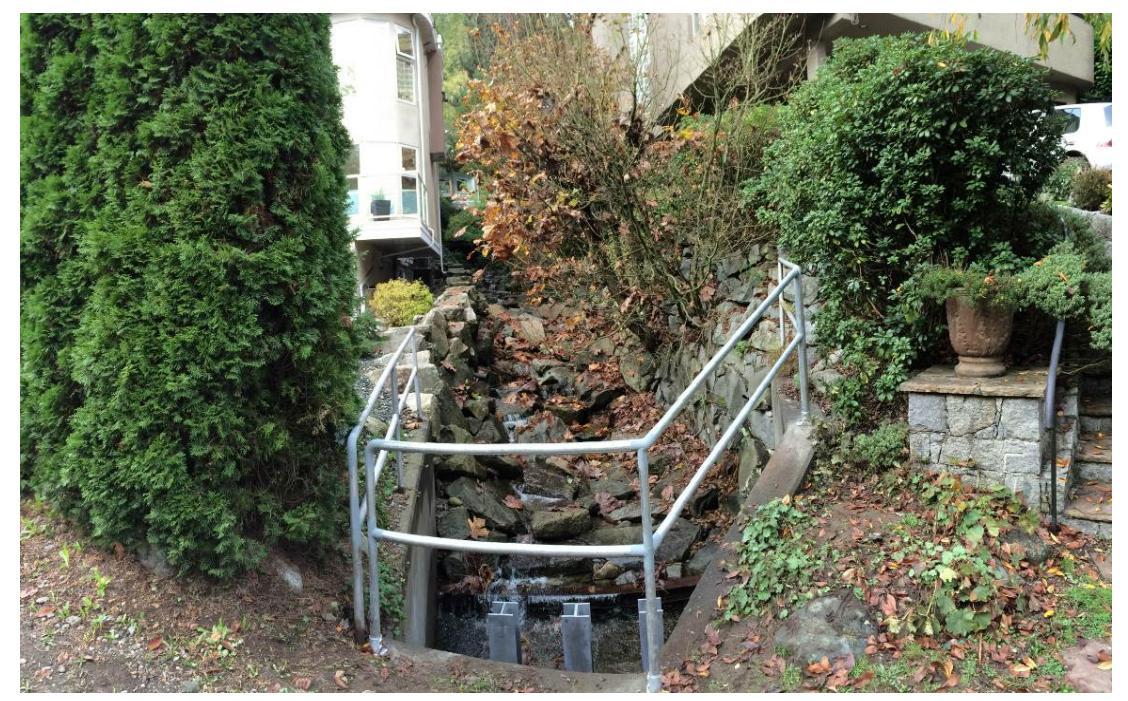
Photograph A.1-19.

Upstream view of constructed debris barrier at Deep Cove Road. BGC photograph of October 19, 2015.

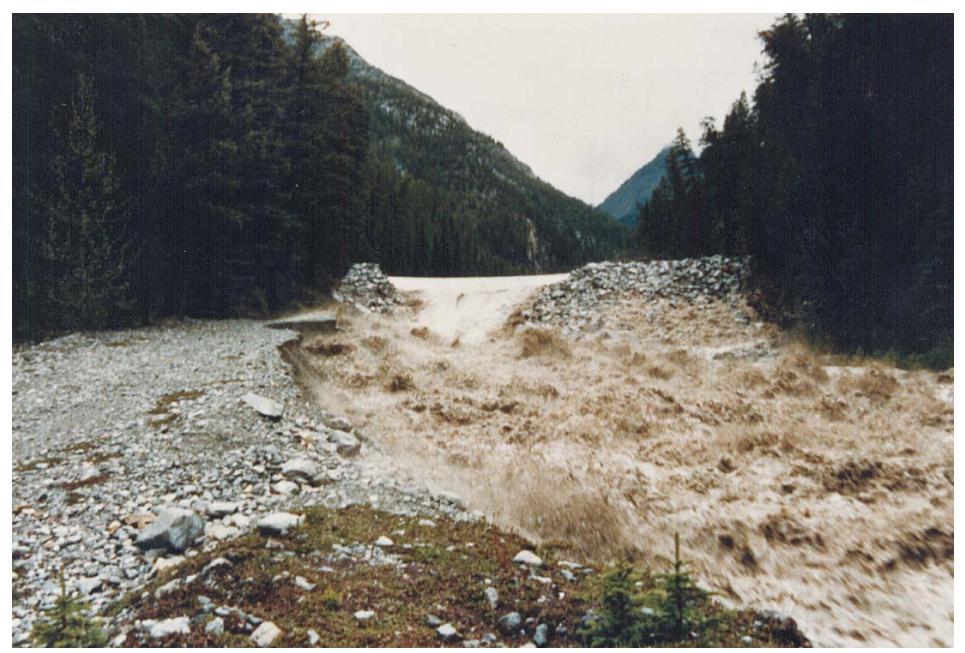
Photograph B.3-1. Example of the failure of a human-made dam on Cougar Creek shortly after the breach initiated. May 25, 1990 (Alberta Environment, 1991).

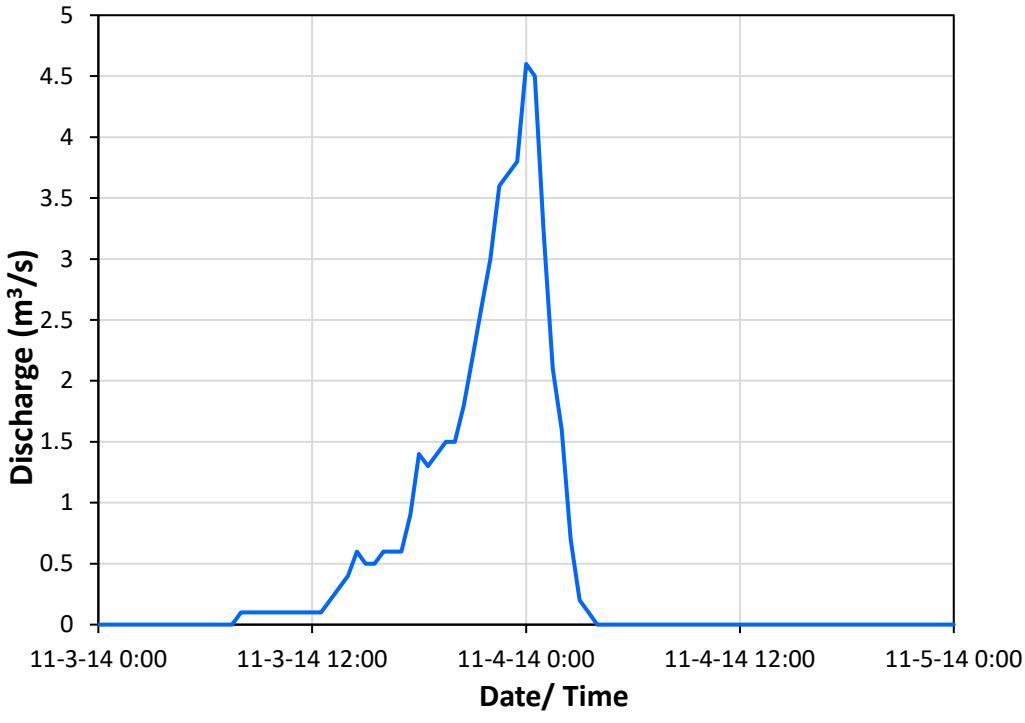
Figure G.3-1. November 3, 2014 hydrograph for Kilmer Creek at Dempsey Road.

The resulting November 2014 hydrograph is shown in Figure G.3-1 for Kilmer Creek at Dempsey Road. The peak instantaneous flow estimate based using the HEC-HMS model and a watershed

area of 0.77 km² is 4.6 m³/s. This result is consistent with a peak flow estimate of 4.4 m³/s derived from high water mark observations (Section A.4.5, Appendix A).

In comparison, the 20-year, 50-year and 200-year return period peak instantaneous flows for Kilmer Creek at Dempsey Road are estimated at 3.3, 4.2 and 5.7 m³/s. The November 3, 2014 event is associated with a return period of about 60 years. BGC is not aware of a major debris flood having initiated on Kilmer Creek since at least the 1960s, when the Kilmer Creek diversion was constructed. The critical discharge for debris flood initiation on Kilmer Creek is between 3.3 m³/s and 4.2 m³/s. For about a 200 m section of Kilmer Creek above Dempsey Road, the creek has a width of about 4.2 m and an average channel gradient of 18%. Using an idealized channel cross-section and Manning's equation, hydraulic radii of 0.57 m and 0.63 m, respectively, are back-calculated for peak flows of 3.3 m³/s and 4.2 m³/s.

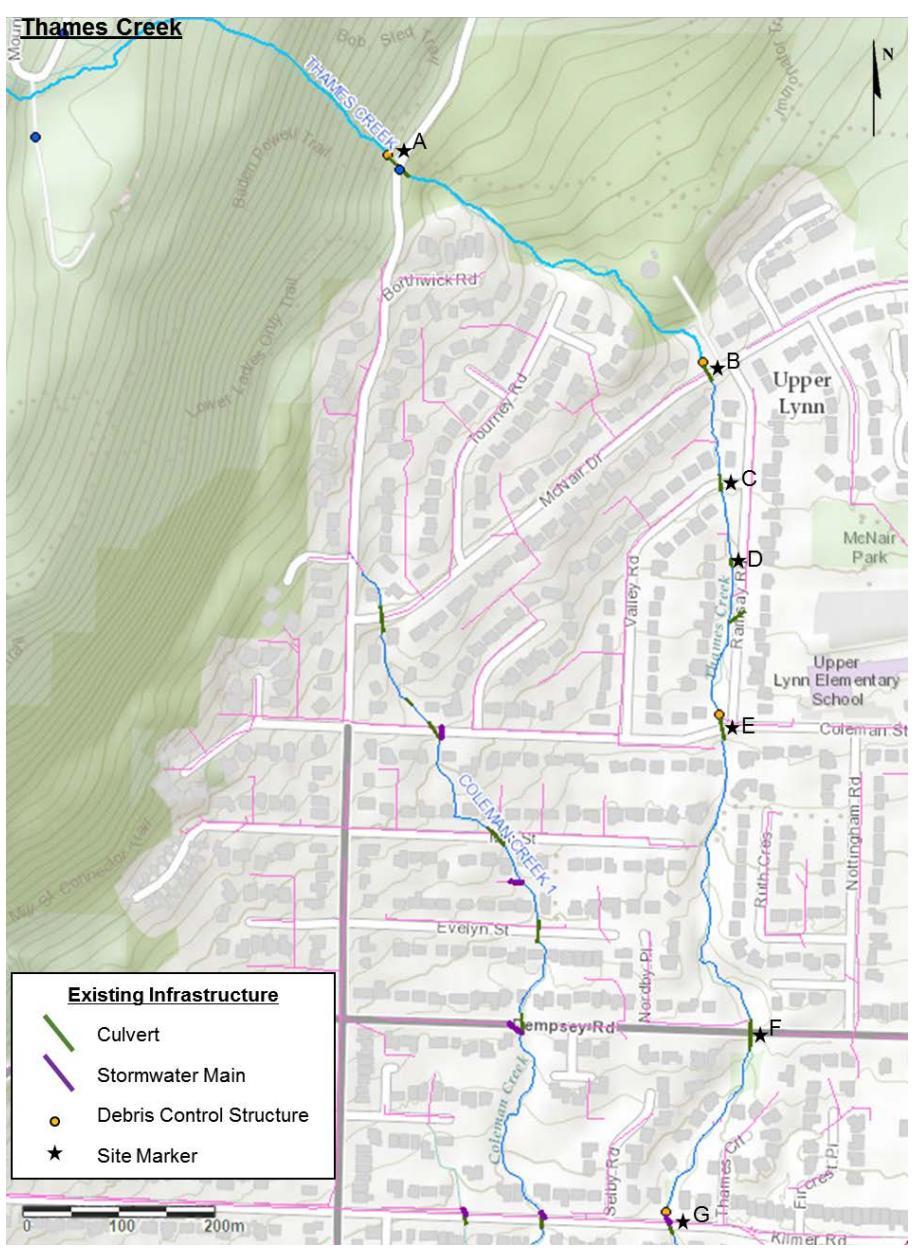
Figure O.8-1. Thames Creek – Culverts and stormwater mains.

Table O.8-2. Thames Creek – Frequency-magnitude estimates of peak flow and sediment volume at the development interface (site B – McNair Rd).

Return Period (years)	Flood Quantile	Peak Discharge (m³/s)	Sediment Volume (m³)
10-30	Q ₂₀	2.2	<10
30-100	Q ₅₀	2.8	185
100-300	Q ₂₀₀	3.9	930
